Department of Administration
Construction Update No. 48
February 22, 2005

Repair Work to Begin Soon on the Terra Cotta Dome

Contractor Making Progress on Masonry Repairs

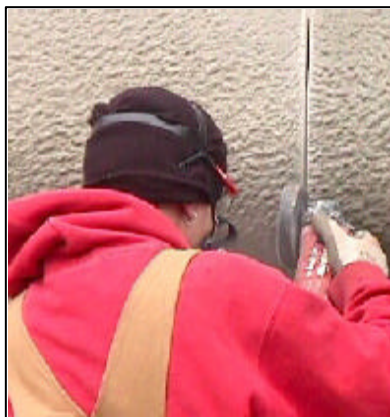
The joint replacement requires specialized mortar removal techniques to determine the soundness of the grout between the pieces of stone.

Using the hand tools, workers remove the old mortar (**photo at left**) and clean the joint to prepare it for installation of new mortar.

New mortar or grout will be installed in a procedure called

"re-pointing". This process is expected to get underway once the temperature warms up above a low of 40 degrees, according to **Jan Frew**, Design and Construction Manager, Division of Public Works.

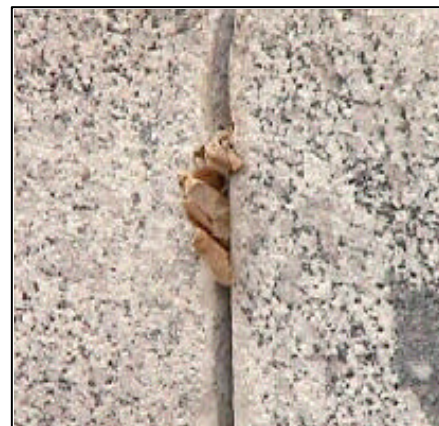
Workers removing old mortar have found paper between the masonry joints, possibly used as a stone spacer.

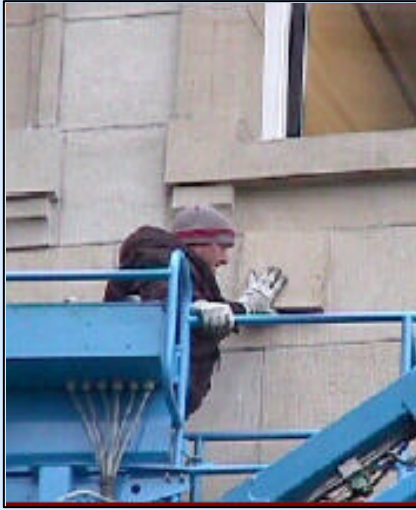
As part of the masonry restoration work, any refinished or replacement sandstone or granite must match the Capitol's existing exterior. **Pictures show** masonry workers comparing samples of new and refinished stones at different elevations of the building.

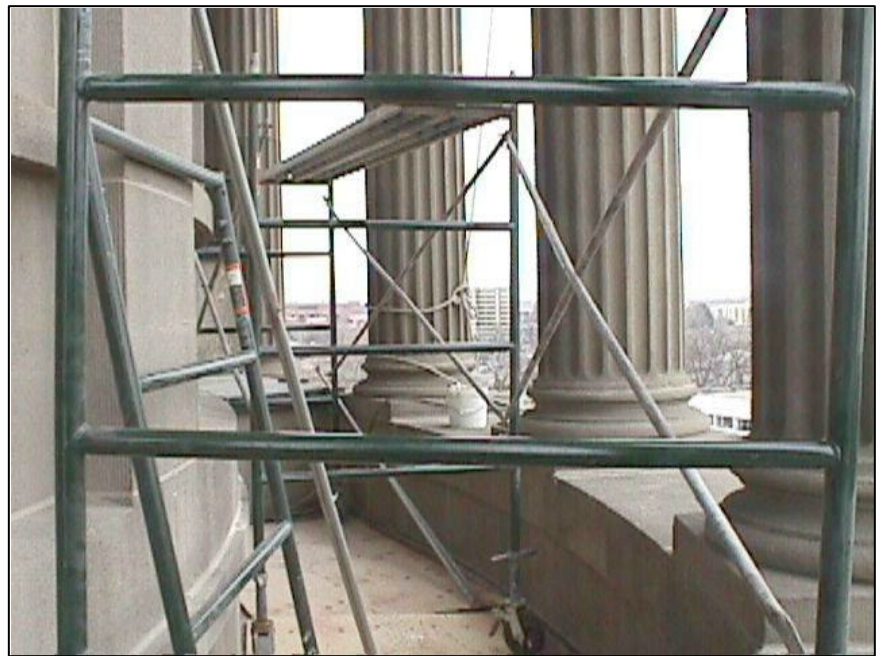
Top Photo: The contractor has erected scaffolding in the Capitol dome drum area as work begins there over the next several weeks. **Bottom Photo:** Masonry joint removal work is evident on the southeast elevation of the building.
